Significant Incident After Action Report

**Augusta County
Residential Structure Fire
716 North Mountain Road
January 7, 2025**

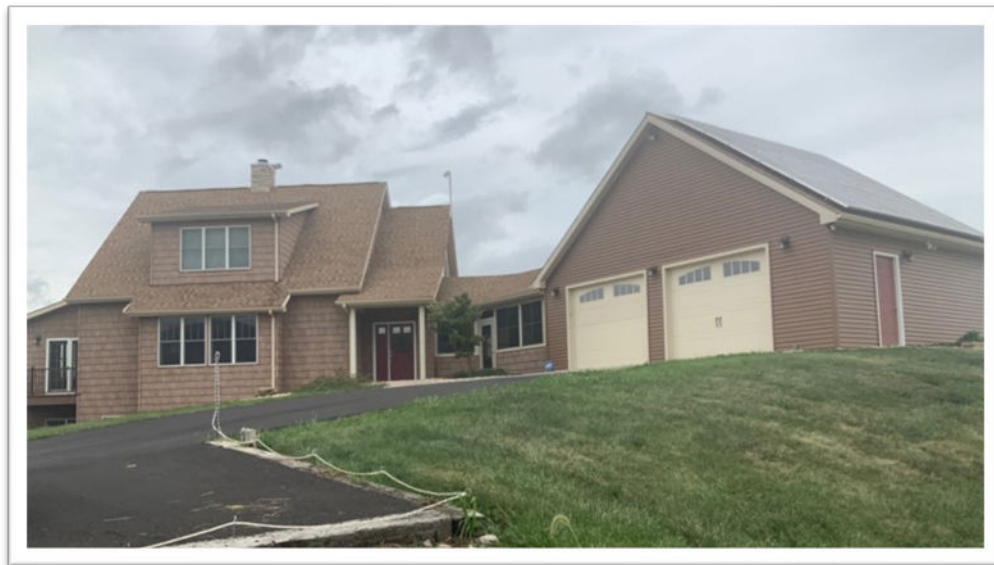
Crews worked to extinguish the fire resulting in a floor collapse and Mayday incident at 11:17. Fire was marked under control at 14:40 with one firefighter transported with minor injuries.

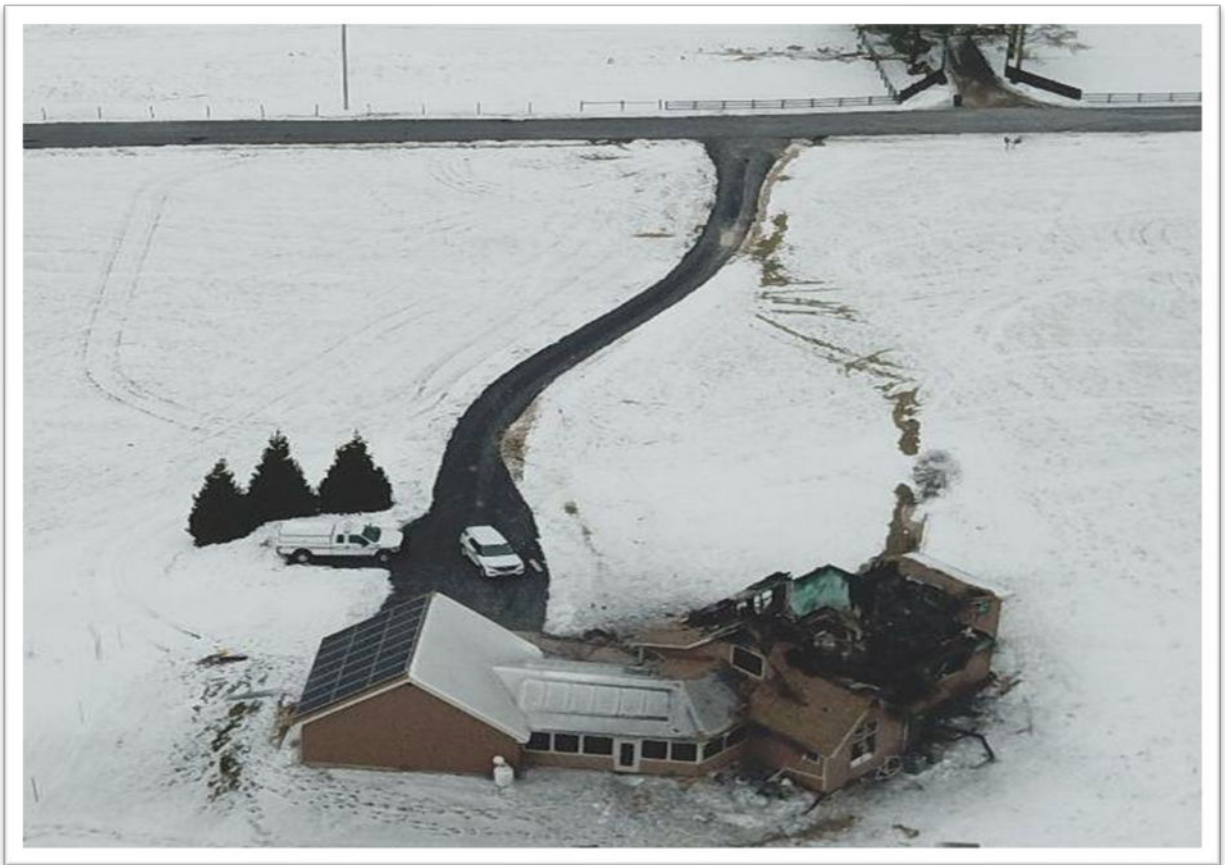
- Two-story single-family dwelling
- Type V wood frame construction
- Walk out basement (Side Bravo)
- Total square footage: 5,717; livable space: 2,872
- Attached breezeway to the two-car garage
- Solar panels with battery back up

- The structure was significantly compromised due to the amount of fire and water damage.
